Use of a Small Unmanned Aircraft System for Autonomous Fire Spotting at the Great Dismal Swamp

Michael J. Logan¹ and Louis J. Glaab²
NASA Langley Research Center, Hampton, Virginia

This paper describes the results of a set of experiments and analyses conducted to evaluate the capability of small unmanned aircraft systems (sUAS) to spot nascent fires in the Great Dismal Swamp (GDS) National Wildlife Refuge. This work is the result of a partnership between the National Aeronautics and Space Administration and the US Fish and Wildlife service specifically to investigate sUAS usage for fire-spotting. The objectives of the current effort were to: 1) Determine suitability and utility of low-cost Small Unmanned Aircraft Systems (sUAS) to detect nascent fires at GDS; 2) Identify and assess the necessary National Airspace System (NAS) integration issues; and 3) Provide information to GDS and the community on system requirements and concepts-of-operation (CONOPS) for conducting fire detection/support mission in the National Airspace and (4) Identify potential applications of intelligent autonomy that would enable or benefit this high-value mission. In addition, data on the ability of vario

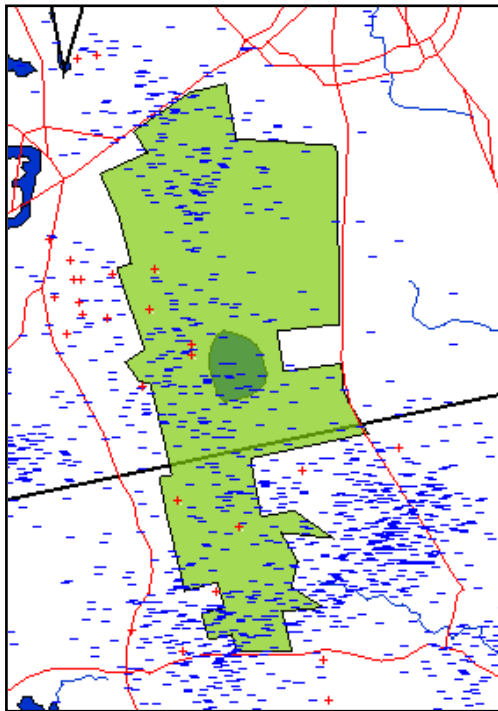
Figure 2 - Example lightning strike data from July 16th, 2013.

Whenever a lightning storm crosses through the GDS, a map of lightning strikes is acquired by GDS personnel (Fig. 2). Negative (dashed icons) indicate negatively-charged strikes, positive lightning strikes are presented by red plus sign icons. While there is some debate regarding the energy and temperature of negatively-charged and positively-charged lightning strikes, all are considered to be potential fire starters and need to be inspected. The current fire-spotting process involves use of manned airborne resources to search for fires and focusing on the lightning strike data. Airborne resources typically include small helicopters which are contracted from a local service. Trained GDS fire-fighting personnel go on fire-spotting missions and look for fires using several techniques. In general, fires are spotted by simply looking for smoke plumes. If a fire is spotted, it is more closely inspected from the air. If the fire is considered threatening to spread into the ground, efforts are made to get to the location via ground based methods to control or extinguish the fire. Fires that are less threatening are monitored from the air. Frequently fires burn themselves out with no need to actually travel to the location. In addition to visually unaided aerial fire-spotting, GDS personnel can also use hand-held infra-red (IR) devices to map boundaries.

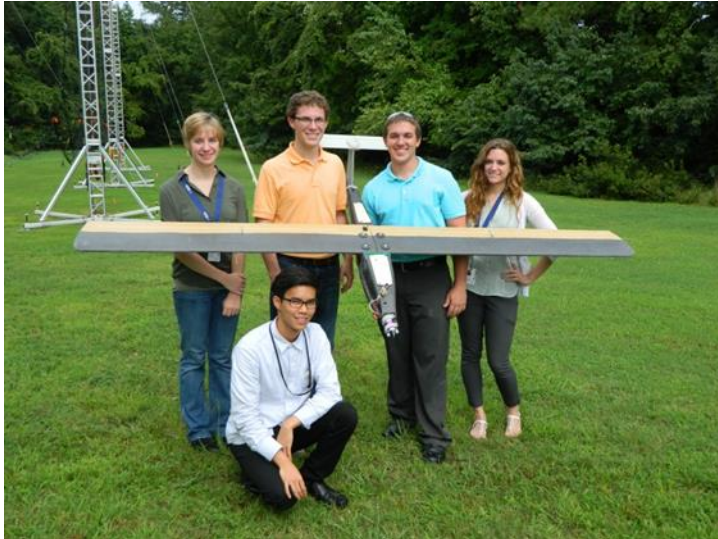
Figure 7 – FireFlyer sUAS

The FireFlyer UAS (Figure 7) was custom-designed and student-built in 2013 (with funding supplied by the UAS-in-the-NAS project and the Aeronautics Academy) specifically to address the GDS fire-spotting mission. Designed to have a 1-hour endurance, it carries a payload of both a forward looking color daylight camera and a down pointing IR camera, both fixed to the airframe. It was initially assumed that this airframe would provide the needed endurance and sensors to evaluate the fire-spotting utility of this class of vehicle. However, during some of the early flight testing for this effort, the airframe was heavily damaged. The cause was a hard landing that was determined to be due to a lack of control authority of the empennage shortly after takeoff. As a result, a significant effort would have been required to re-design and re-fit the aircraft with a new empennage for use in this research activity. It was determined that this would not be advantageous to achieving the project cost or schedule constraints.

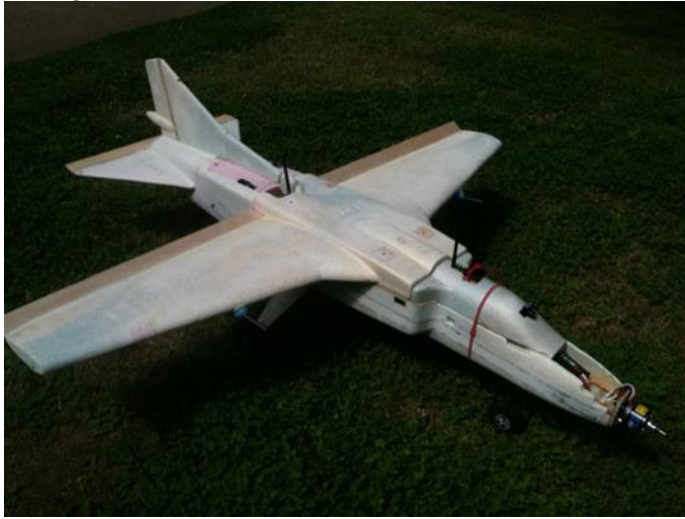
Figure 8 - NASA Modified FQM-117B, tail designator LH

The NASA-modified Army target drone, formerly designated as an FQM-117B (Figure 8) is a 1/9th scale Mig-27 foam aircraft that was selected for this effort to simply test the avionics in a relevant fire-searching environment at a minimum cost. Several Mig airframes were available at the start of the project that were leveraged for this effort. The Mig has a wingspan of 5'6" and an overall length of 6 ft. The design takeoff weight of the Mig as a target drone was specified at 8 lbs, but for the current effort the vehicle was operated at 15 lbs. Much of the increase in weight was due to the addition of a landing gear and electric propulsion system. Some of the benefits of the Mig included large internal payload volume and easily modifiable foam construction.

Initially, the MigLH was powered by an E-Flite Power 90 electric motor with a 16" propeller. During operational testing at the grass strip at the Military Aviation Museum the need for a higher takeoff thrust margin was discovered. Subsequent propulsion was provided by an E-Flite Power 160 outrunner style electric motor powered by a 10-cell 7800 mah battery pack. Overall, this propulsion system provided adequate thrust and approximately 15 minutes of flight time while maintaining a 20% battery reserve. Electric propulsion was beneficial for this effort since it produces a lower vibrational environment compared to reciprocating engines, and does not produce emissions that could form residues on the aircraft and compromise camera views. Electric propulsion is also considered likely for an actual fire-spotting aircraft due to environmental considerations at the refuge such as noise and emissions. Radio control (R/C) of the Mig was accomplished using a JR/Spectrum 12X transmitter and 1222X receiver. Once the aircraft was airborne and stabilized at the desired observation altitude, control was transferred to the autopilot using one of the switches on the 12X. As a result of its design as an inexpensive and rapidly-assembled target drone, the Mig's aerodynamics, high weight, and limited endurance of the vehicle and rendered it unsuitable as an actual fire-spotting aircraft. However, the Mig did meet all of the testing needs for this effort.

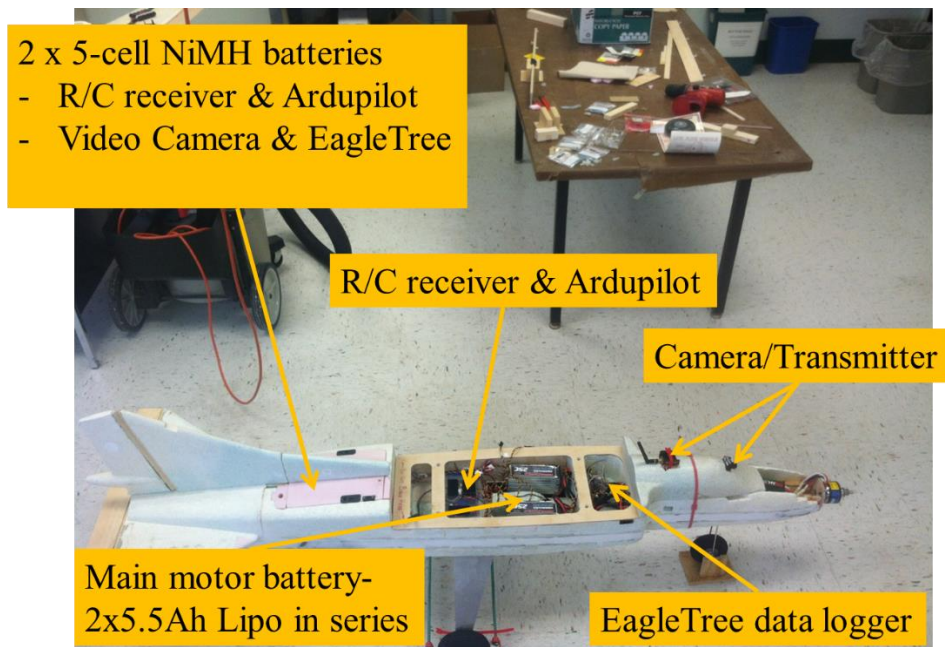
Figure 9 - Interior of MigLH.

Additional NASA modifications from the bare airframe included the addition of a landing gear, rudder, fuselage reinforcement, and three payload bays. Details can be seen in Figure 9.

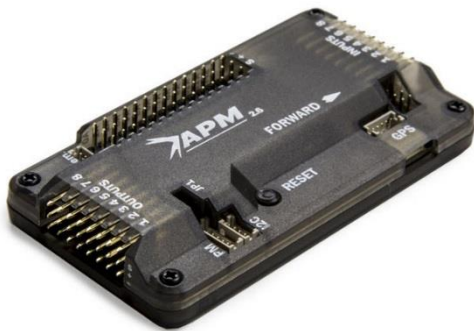
Figure 10 - Ardupilot 2.6.

In addition to an EagleTree data logger, an Ardupilot autonavigation unit was installed in the vehicle. The Ardupilot, shown in Figure 10, was chosen as a COTS autopilot representative of the type of low-cost unit an affordable UAS would likely have to use. The cost of the Ardupilot unit was less than \$500. During the initial flight testing, this proved to be somewhat problematic for two reasons. First, the autonav unit itself is not “general purpose” in that it has several parameters which must be set properly, including PID gains, outer-loop control parameters, and others. Tuning these parameters required an inordinate amount of flight testing as there was no concise documentation on how to compute these parameters from known physical quantities. Second, the

reliability of the compass and GPS sensors was less than optimal, and, in some cases, the apparent failure of these sensors was not readily detected by on-board diagnostic hardware and software. This greatly complicated the “tuning” process since it was unclear after a change whether the adverse response was due to the parameter being changed or the sensor failing. Eventually, a new version of the autopilot became available which provided an external, easily replaceable module containing both an upgraded GPS and more reliable compass module. This greatly improved the ability to tune the autopilot to the system. After dozens of flights oriented towards tuning with little progress, once the system was proven reliable, it took less than 6 flights to get the autopilot sufficiently tuned to perform the research flight tests and demonstration. Acceptable performance for this effort was defined as autopilot-like controlled flight over various test fires with aircraft attitude variations less than ± 10 degrees, altitude error less than ± 10 meters, airspeed error less than ± 3 meters/second. Further adjustments to the autopilot parameters could have slightly improved the control of the aircraft, however, schedule constraints precluded additional autopilot tuning.

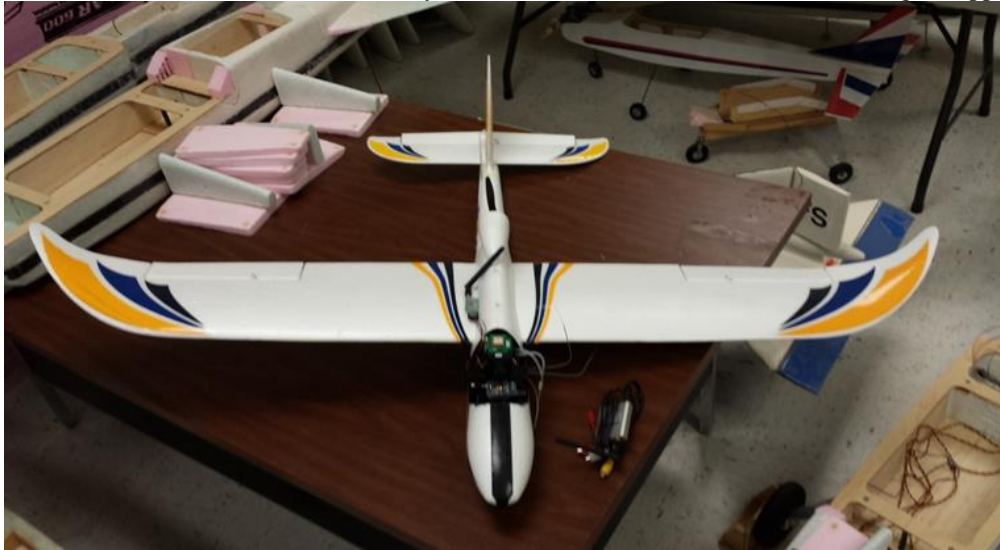
Figure 11 - Bixler COTS sUAS.

The Bixler UAS, sold by 3-D Robotics and shown in Figure 11, is representative of the class of small, hand-launched vehicles that are currently available in the US market. It weighs approximately 3.5lb. and

has a wingspan of less than 5ft. It uses the Ardupilot autopilot similar to what was installed in MigLH. It is equipped with a color daylight camera and video overlay. Flight tests with this platform initially had the same reliability issues as the same unit in MigLH. Subsequent upgrade of the autonav unit provided much better reliability, similar to what was seen with the MigLH. It was felt that whereas the MigLH requires a “runway” for takeoff and landing, the Bixler had more utility since it required far less of an operating area for launch and recovery due to being hand-launched and belly landing recovery. Flight speeds were much lower for the Bixler than those of the MigLH.

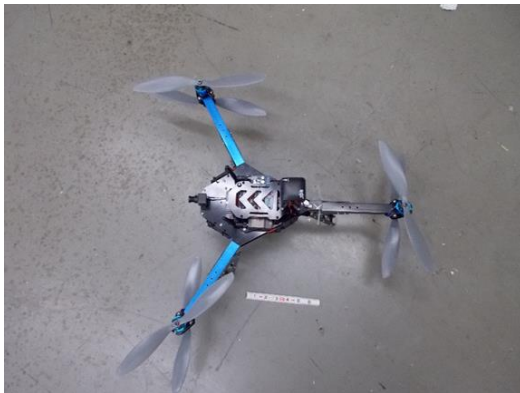
Figure 12 - 3D Robotics Y-6 V/TOL sUAS

The Y-6 (Figure 12) is a small (< 4lb) multi-copter sold by 3D Robotics. It has 6 motors mounted in a Y-shaped frame. The basic vehicle comes with a body-fixed color daylight camera with overlay data from the on-board autopilot unit. While this particular platform uses the more advanced Pixhawk autopilot from 3D Robotics, the initial autopilot unit suffered an IMU failure during its first flight. After replacement, no further autopilot issues were discovered. Replacement of two of the electronic speed controllers was required after the system developed a tendency to shut down one of the motors on one leg. After replacement, no further issues have been encountered.

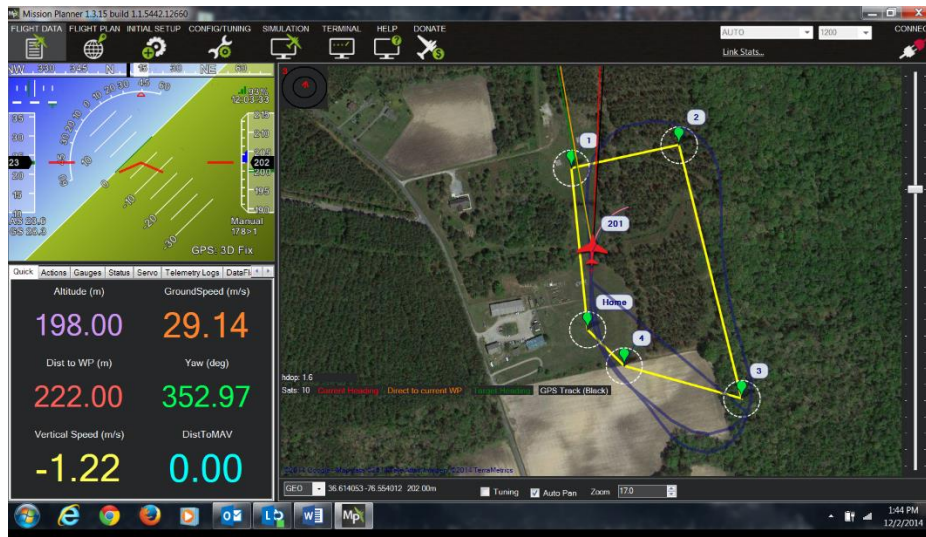
Figure 13 - Image from the Mission Planner software.

Mission Planner is provided in Figure 13. In Figure 13, it can be seen that Heads-Up-Display (HUD)-like aircraft airspeed, altitude, and other parameters are provided in the upper left of the Mission Planner display. A gods-eye-view map, showing waypoints, desired route, and aircraft location are shown on the right in Figure 13. Quick-view parameters including altitude, ground-speed, distance to next waypoint, heading, vertical speed, and distance to the home point are provided in the lower left of the Mission Planner display. The autopilot laptop was a commercially available ruggedized unit running Windows 7. The 4-G wireless hotspot was required to support

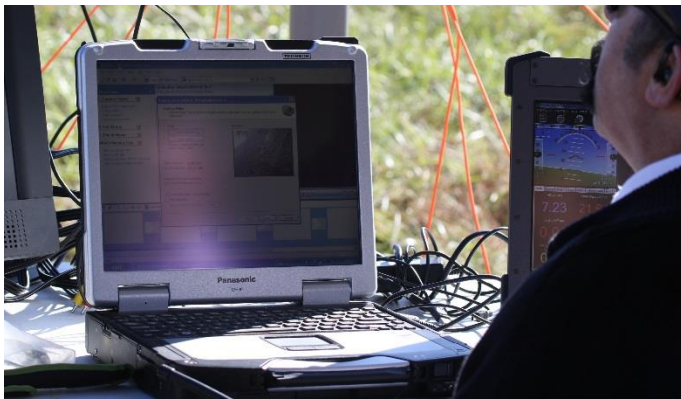
Figure 14 – Video control ground station.

downloading of the terrain maps for the APM software. Pre-loading the terrain maps was also an option for the APM software. The video recording laptop was a standard computer running Windows XP. Its function was to support configuration of the video telemetry system, monitoring the telemetered video during flight, and capturing and recording the video to the hard-drive for subsequent analysis. Figure 14 provides a photograph of video control portion of the ground station. The Autopilot datalink operated on the 900 MHz frequency band while the Video datalink operated on the 5.8 GHz band.

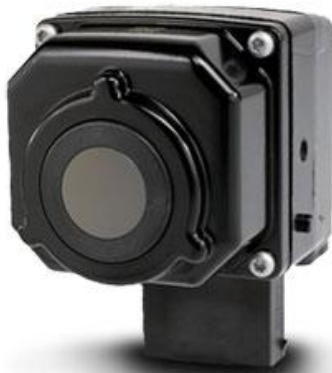
Figure 15 - PathFindIR camera from FLIR Systems.

detecting the hot spots would be preferable. However, the needed level of performance required was not known a priori. Initially, only a low-performance IR sensor was available, a 160x120 (interlaced to 320x240) resolution as shown in Figure 15. Acquisition of a 336x240 and 640x480 was initiated on the expectation that the additional resolution and sensitivity would be needed for the detection. The camera has a horizontal field of view (FOV) of 36 deg. Current cost of this type of low performance IR sensor is about \$2500.

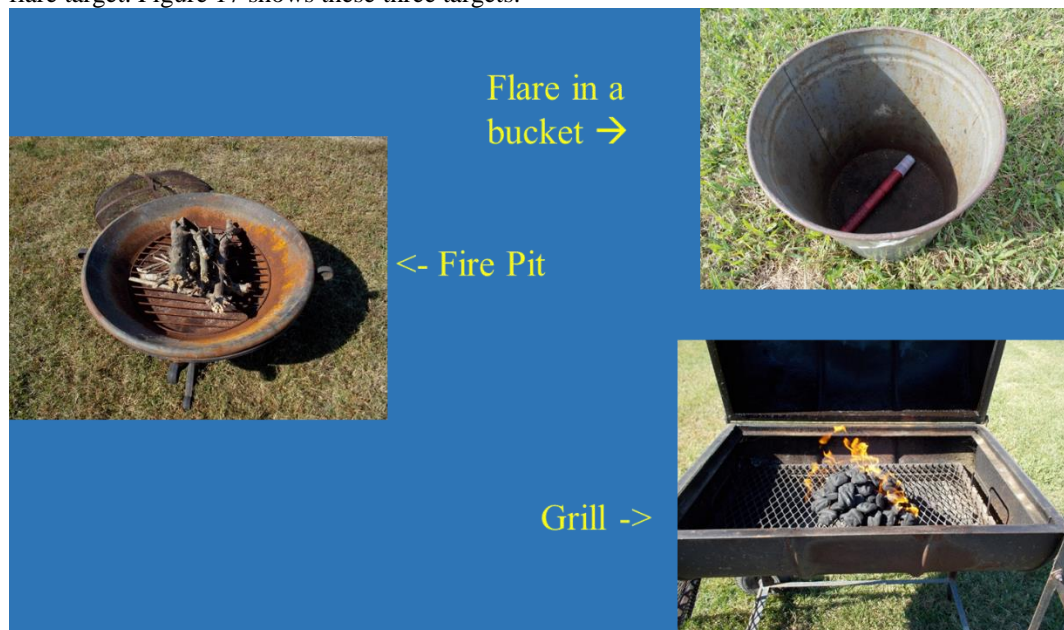
Figure 17 - Representative fire targets

In order to test the efficacy of the sensor suite and the platform to perform basic fire detection tasks, a series of flight tests were conducted using simulated targets of different types. First, a road flare was placed in a metal bucket and lit. This would represent an easy to implement, low cost method of providing a target with the hottest target temperature likely to be encountered (roughly 2000deg. F). Second, a fire pit approximately 3ft in diameter with indigenous organic material such as wood branches, leaves, pine needles and peat moss were used as representative of a “nascent” fire similar to what would be expected at GDS. Third, a typical steel grill was used with a charcoal fire and the lid closed to concentrate the plume and somewhat attenuate the temperature signature during the test. The fire pit and steel grill were implemented after the initial set of flights showed adequate detection of the road flare target. Figure 17 shows these three targets.

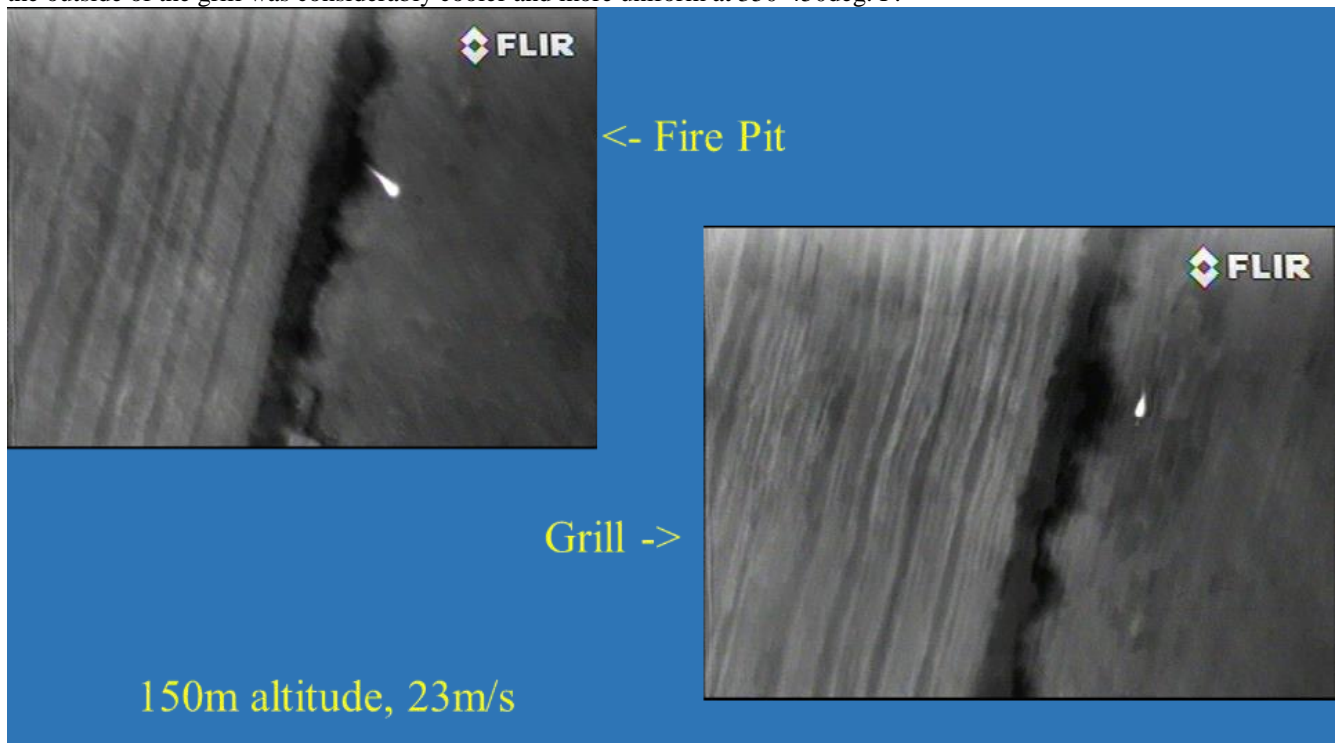
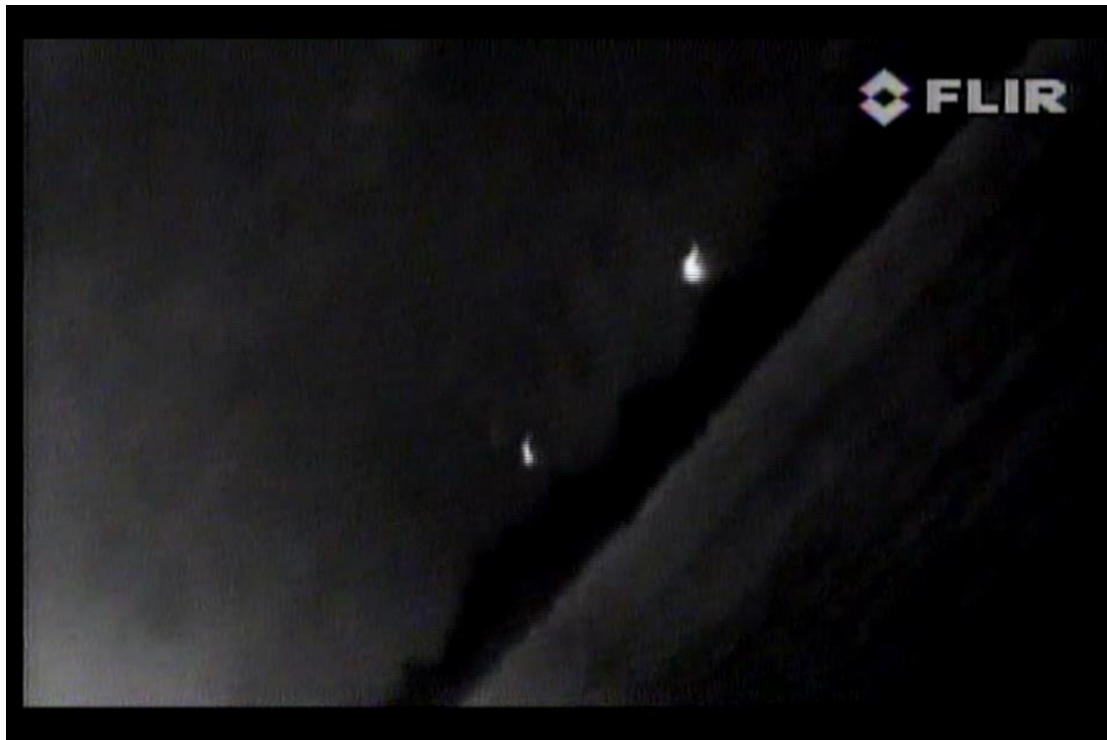
Both the fire pit and grill were clearly visible in the IR imagery. An example of this is shown in Figures 18 and 19. Note that at the higher altitude of 200m (656ft), both targets were visible simultaneously owing to the wider ground swath of the camera at the higher altitude. At an altitude of 200m (656ft), the camera could view a 124m (407ft) wide track on the ground. One pixel represented approximately 0.8m (2.6ft.) on the ground. Temperatures of the fire pit ranged from 300-700deg. F depending on where in the fire the temperature was measured. The temperature of the outside of the grill was considerably cooler and more uniform at 350-450deg. F.

Figure 18 - IR image from video, 150m altitude, 23m/s airspeed

Figure 19 - IR still image from video, 200m altitude, 23m/s airspeed

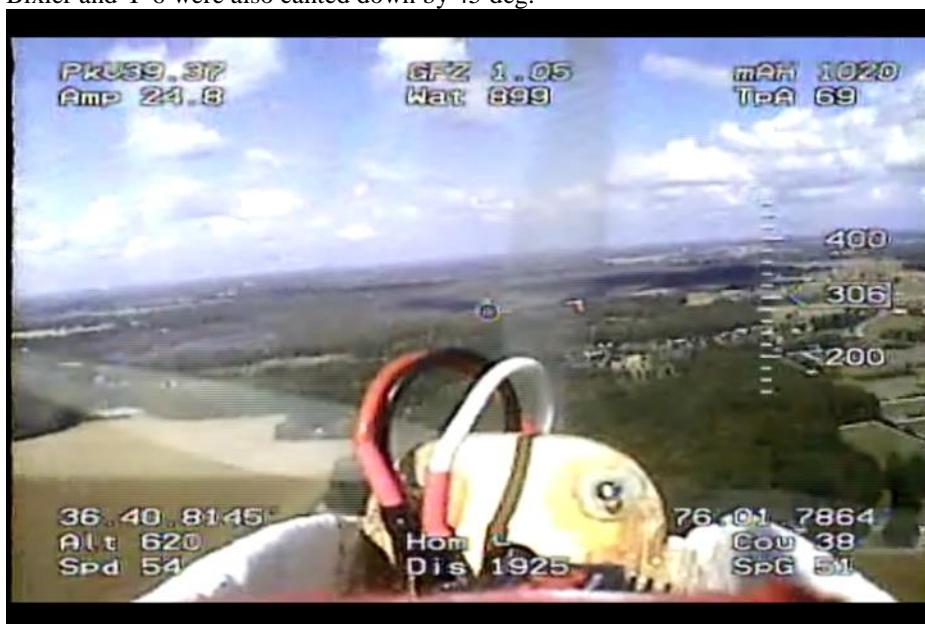
Figure 10 - MigLH forward facing camera image.

During the flights, neither the MigLH nor the Bixler's color daylight camera provided video watchers with sufficient imagery to visually detect smoke plumes. It was later determined this was largely due to the use of very open space to place the targets and the subsequent rapid wind dissipation of the plumes. In addition, it was determined that the forward facing cameras on all platforms needed to have a more downward cant, and in the case of the MigLH be relocated to the bottom of the aircraft, to provide better plume imagery. Note that for the initial MigLH flights, much of the downward portion of the image was obscured by the airframe itself (see Figure 20). As a result, the forward facing camera was moved to the bottom of the airframe and re-installed at a 45deg. cant downward. Cameras on the Bixler and Y-6 were also canted down by 45 deg.

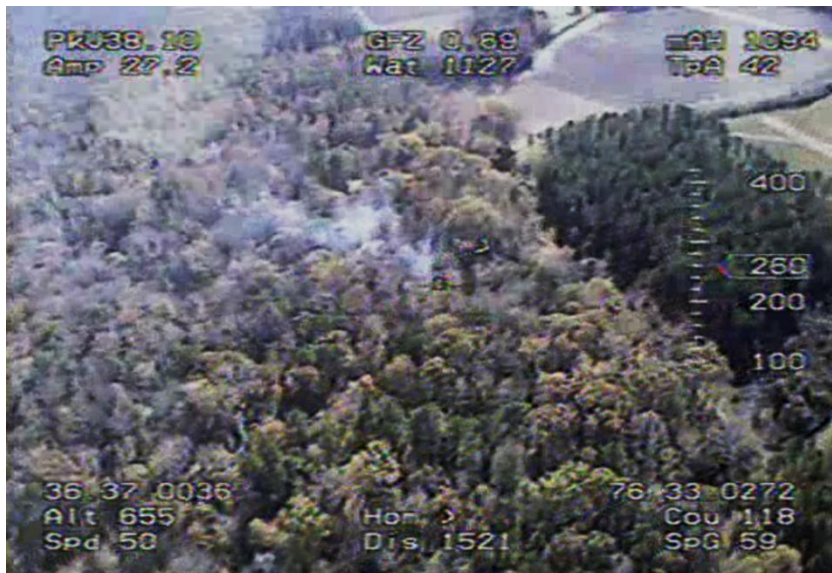
Figure 23 - Example of the 45-deg Look Down camera video.

Figure 23 presents an example of the 45-deg look-down camera video showing the flight data overlay. Existing battery voltage (38.10v) and current draw (27.2 A) are displayed in the upper left of Figure 10. At the top of Figure 10 is the normal force in g-s (0.69) and the present Watt consumption (1127) of the aircraft. The amount of energy consumed by the flight in milli-amp-hours (mAh) (1094) and temperature of the engine batteries, TpA (42 deg F) is displayed in the upper right of Figure 23. Barometric altitude (260 m) is displayed in tape format in meters on the

right of Figure 23. Current latitude (36.37' 0035") and longitude (76.33' 0272") are displayed in degrees, minutes, and seconds, in the upper data fields on the lower left and right of Figure 10, respectively. GPS location combined with aircraft altitude, attitude, and heading can be used to pinpoint fire locations on the ground. Below latitude and longitude are the GPS altitude (655 ft) on the left and GPS ground track, Cou (118 degrees) on the right. In the middle is an arrow indicating which direction to turn to fly back to the home location. On the lower left is indicated airspeed (50 mph), distance to the home location (1,521 ft) in the center, and GPS ground speed (59 mph) on the right. Also visible in

Figure 23 is one of the smoke plumes from the fires created in support of the flight test effort. During the same flight, the IR imagery showed the fire burning. With the 200m (656ft) altitude and ~25m/s (56mph) airspeed the fire hot spot was visible for several seconds. Figure 24 shows an example of a still image extracted from the video.

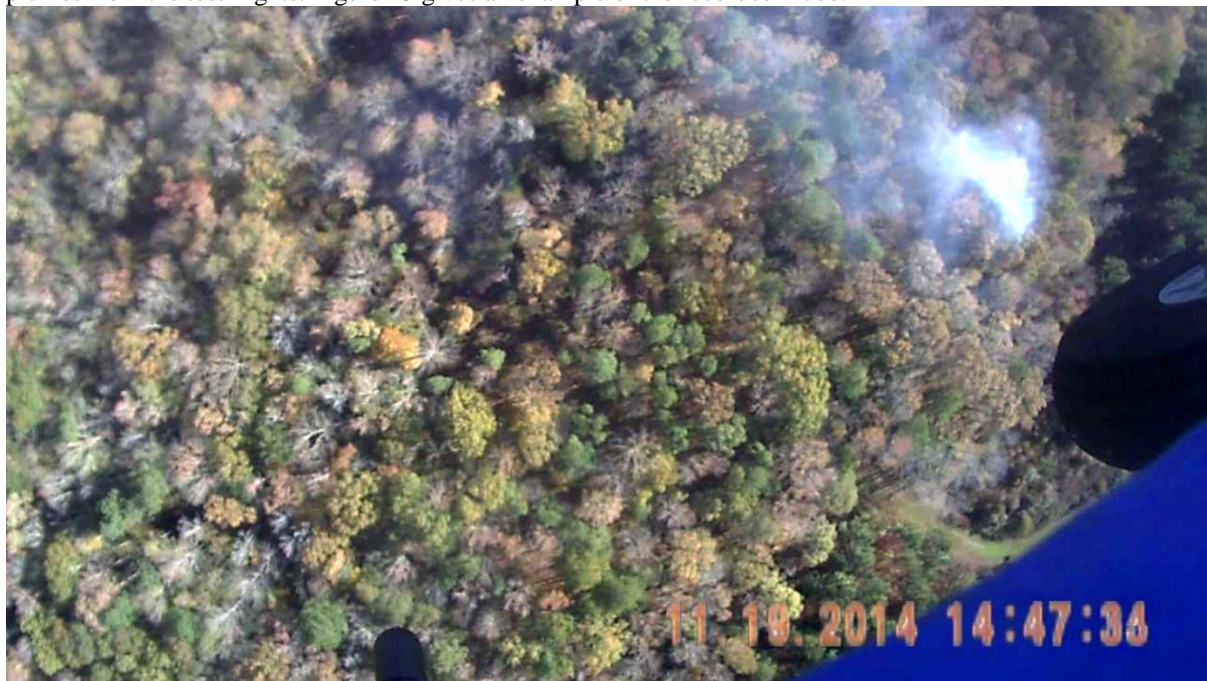
Figure 25 - Smoke plume from training fire captured by 720p video camera.

The second flight of the MigLH platform flew over a training fire of a series of small ignition sources. IR imagery showed the multiple ignition sources clearly. In both flights, the 720p recorded video easily captured the smoke plumes from the test flights. Figure 25 gives an example of the recorded video.

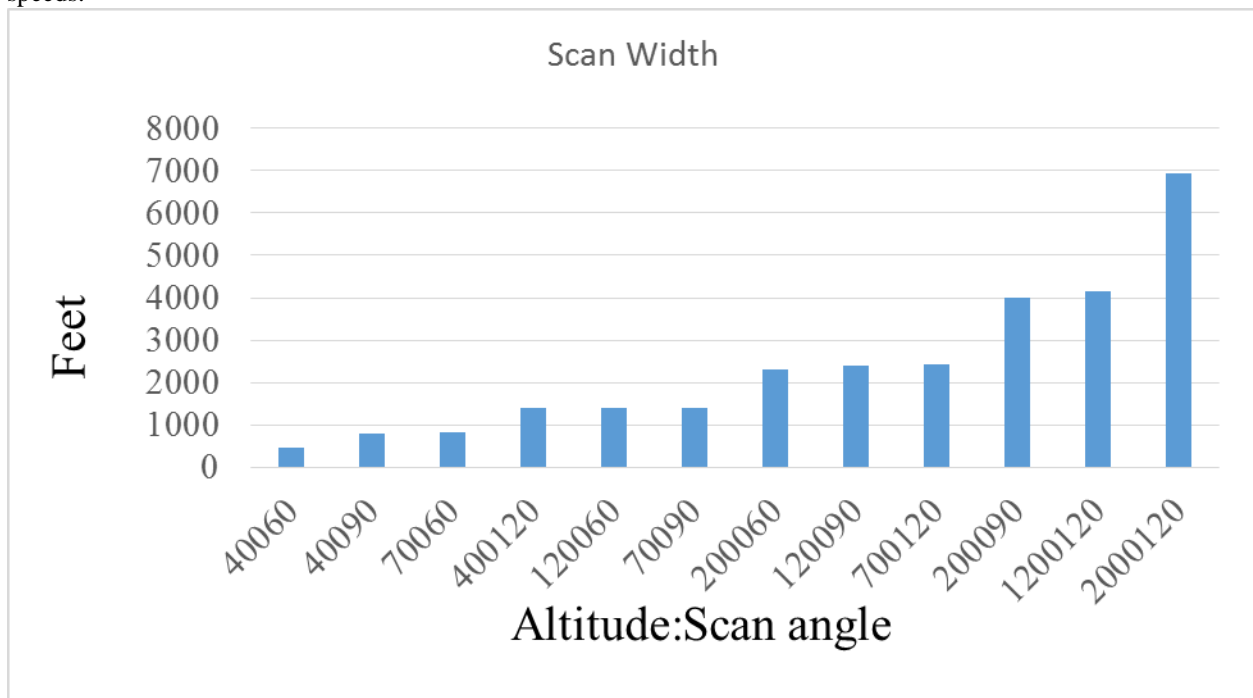
Figure 30 Ground scan width for a combination of altitude and sensor FOV.

For this analysis, altitudes of 400, 700, 1200, and 2000 feet were evaluated. These altitudes correspond to the lowest, most restrictive, maximum altitude for UAS operations (400 ft, 122m), the upper limit of Class-G airspace over the northern portion of the GDS (700 ft, 213m), the upper limit of Class-G airspace of the southern portion of the GDS (1,200ft, 366m), and the altitude that GA aircraft need to stay at or above while flying over the GDS (2,000ft, 610m) because of its status as a National Wildlife Refuge. Figure 30 illustrates the scan width for combinations of altitudes (400, 700, 1200, and 2000) and scan angles (60, 90, 120) for a downward-looking camera. Note in Figure 31 that the labels for the abscissa are concatenations of the scan altitude and scan angle. The results are sorted from lowest to greatest. From Figure 30, it can be seen that the effective scan widths range from as low as approximately 500 feet for the 400 ft scan altitude with 60 deg scan angle up to almost 7,000 ft for the 2,000 ft scan altitude with 120 scan angle. It can also be seen in Figure 31 that results were similar for different combinations of altitude and scan angle. For example, the results for the 700 ft and 120 deg scan angle were nearly the same as the 1,200 ft, 90 deg, and 2,000 ft, 60 deg combinations. While the similar scan widths can be achieved for these three combinations of scan altitude and scan angle, the primary difference would be the size of the camera pixel on the ground. Higher resolution cameras would likely be needed for higher altitude fire-spotting. Figure 32 illustrates the time required to scan the GDS for the series of altitudes and sensor scan angles described above for speeds from as slow as 20 mph up to 120 mph. The time required to perform the 180 deg turn to start the next scan is not included. The resulting time only indicates actual flight time and does include pre-flight or other preparation time. What can be seen from Figure 32 is that the 400ft scanning altitude meets an assumed 8-hr requirement only for scan angles of 120 degrees and speeds greater than ~95 mph. This speed may not be achievable for a low-cost UAS. Results for the 700 ft scanning altitude are better with both the 90- and 120-degree scan angles being feasible. Speeds as slow as ~55 mph could scan the entire GDS with a 120 deg HFOV at 700 ft. Increasing the scan altitude to 1,200 and increasing the scan angle to 120 degrees would be required to enable slower, more efficient, scan speeds of ~35 mph. The 2,000 ft scanning altitude would enable use of narrow field of view cameras and/or slower scanning speeds.

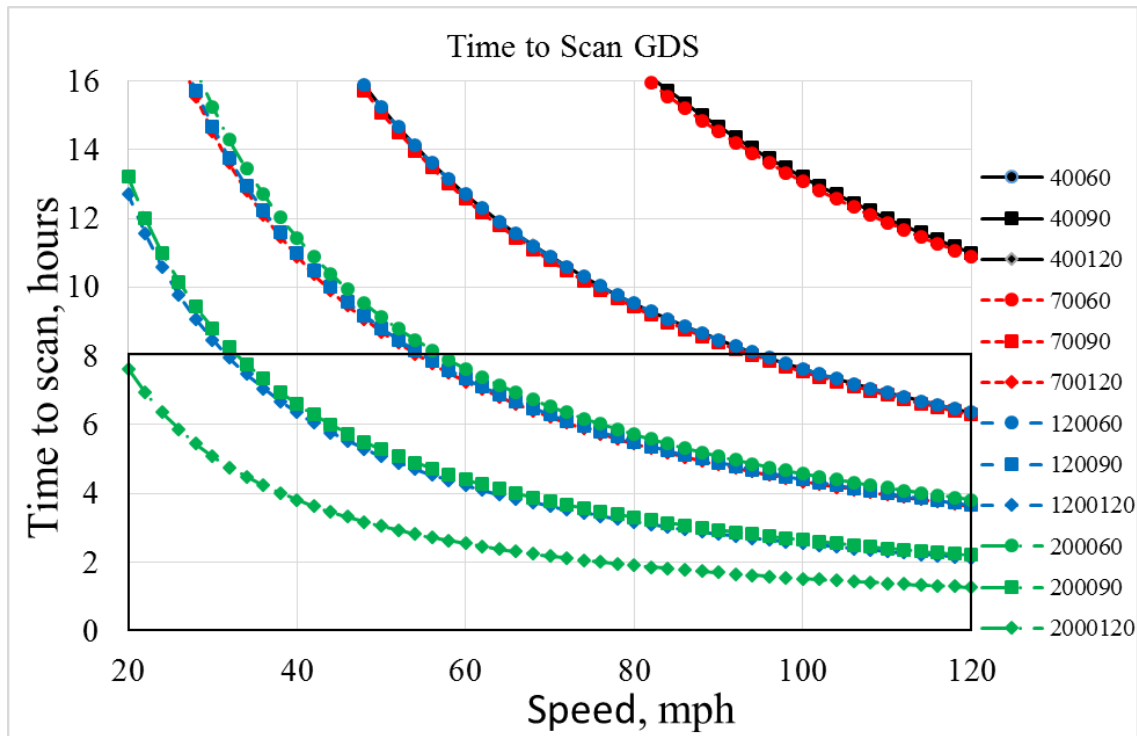
Figure 31 – Estimated Time to Scan the GDS

One of the primary design variables to be considered for the GDS fire spotting mission is system endurance required, and relatedly, speed and altitude for the mission. Therefore, an analysis was conducted to investigate the impacts of elements such as altitude available, vehicle speed, and sensor FOV to the time required to image the entire GDS. The analysis assumed the entire GDS would be searched in a simple stacked-row pattern, with turn time between rows ignored.

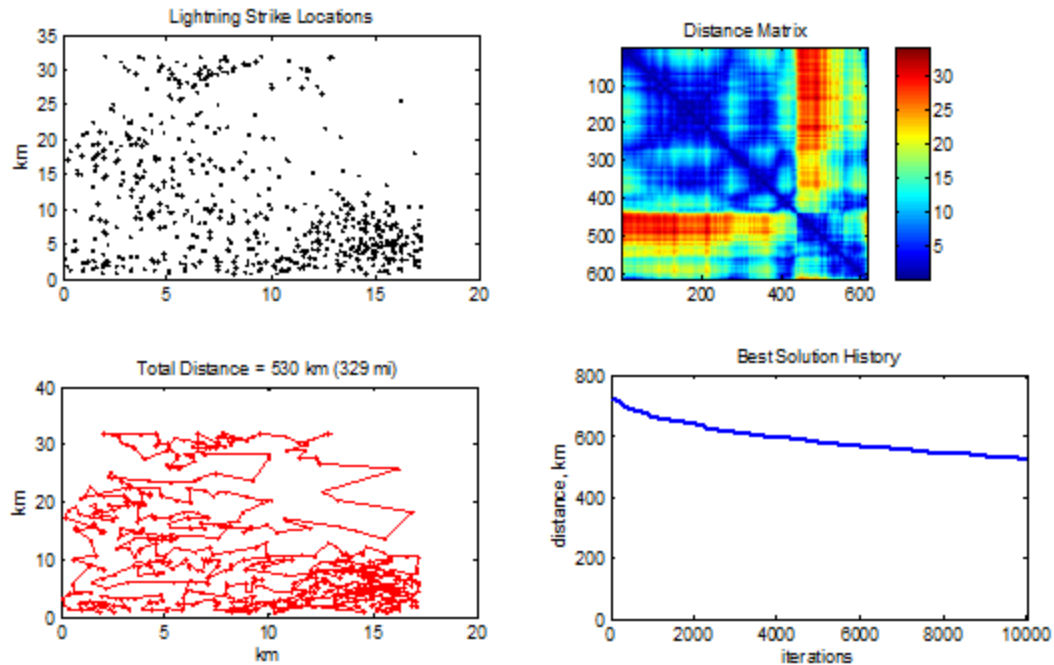
Figure 22 - Genetic Algorithm Reduction in Search Time.

The previous analysis assumed a “lawn mower” pattern which traverses the entire GDS. An initial attempt was made to develop an optimized route to survey the lightning-strike locations using a genetic algorithm. In the figure below, the 617 lightning strike locations from Figure 2 that were within the GDS were referenced to the south-west corner of the GDS. Distances were measured in kilometers for this initial route optimization effort. The lightning strike data was partially sorted as a result of previous route optimization effort which is the reason for the color patterns in the distance matrix. Distances between lightning strikes ranged from a few meters up to greater than 30 km. For this solution the genetic algorithm population size was set to 2,000 and a total of 50,000 iterations were performed which took 2 hours to run on a standard laptop PC. The genetic algorithm solved the traveling salesman problem and created a route that was 419 km (260 mi) long. The result of this is that a UAS would require to fly at a speed of ~33 mph to fly to all of the 617 lightning strikes in 8 hours of flight time or 43 mph for 6 hours. This is significant in that if airspace integration requires the UAS to fly at low altitudes (i.e. 400 ft), then searching the swamp in an organized lawn-mower pattern would be time and/or speed prohibitive as indicated in Figure 31. If it can be assumed that the nascent fires are only at the lightning strike locations, the GDS could be scanned for fires by overflying all of the lightning strike locations. Operations at lower altitudes could also provide some improved capabilities due to the ability to operate when cloud ceilings were lower than required for manned operations. The lightning strike activity used for this analysis was provided by GDS personnel and it is unclear if this is indicative of low, average, or an extremely-high amount of lightning strikes. This analysis points towards one possible future application of intelligent autonomy – reducing the required endurance (and subsequent expense) of the system required to scan the GDS.

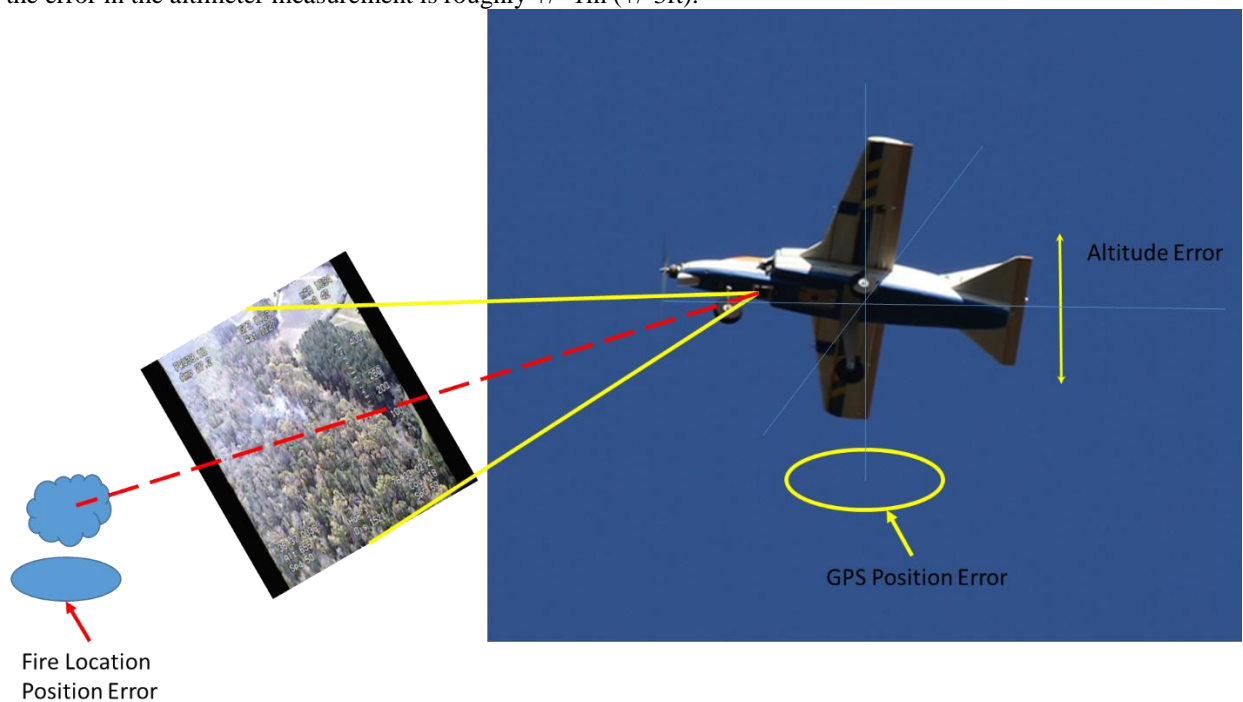
Figure 33 - Fire Location Error diagram.

Another analysis that is instructive is one dealing with geo-location of the fire using the data and imagery acquired. Establishing a baseline error in the location will provide a basis upon which a future system requirement can be based. Figure 33 shows the basic position error analysis. Using a body-fixed camera limits the accuracy of the geo-location. The GPS system in flight often has a horizontal dilution of position of approximately 1m (3ft.). Similarly, the error in the altimeter measurement is roughly ± 1 m (± 3 ft).

At an altitude of 700ft., the ground position error, assuming no pitch, roll, or yaw angles would be +/- 3.5ft. However, in flight, the roll, pitch and yaw variability can exceed 2deg, further adding as much as 50m (164ft) to the potential fire location position error. If the aircraft's "pose" data from the on-board inertial measurement unit (IMU) can also be incorporated and synchronized with the image data, then the error gets reduced back to simply the GPS error and altitude measurement error and the accuracy of the IMU data. Another clear possibility is to consider the use of 3-axis stabilized gimbaled sensors, which would eliminate the need for frame-accurate synchronization of the video with the autopilot IMU data but with the incurred size, weight, drag, cost, and complexity of the gimbal unit considered as part of the design space.
